Manhole Inspection Summary

Manhole # S09QQ1013MH

Insp Date: **12/29/08 11:04 AM**

Location Address: **3041 BELVEDERE AVE**

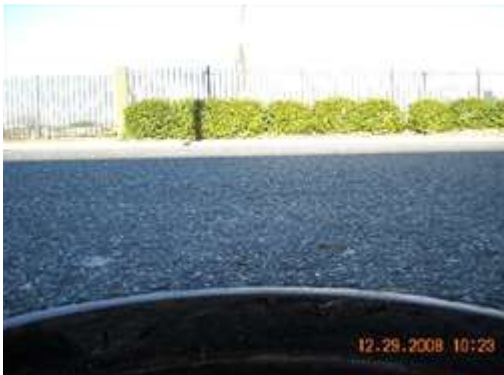
Subject To Ponding: **Sheeting**

EVIDENCE OF SHEETING

EVIDENCE OF INFLOW DUE TO SHEETING FROM CROWN OF ROADWAY.

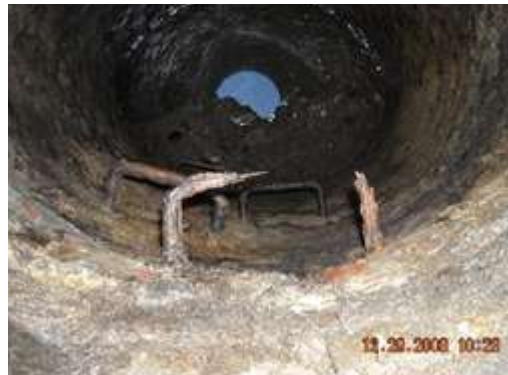
Defect 2

Count: **3** Missing: **1** ☒ **Corroded**

CORRODED TOP STEP

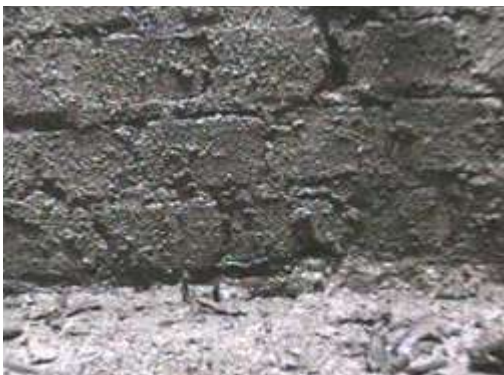
Defect 4

☒ **Evidence Of Surcharge** Depth: **1** (ft.) ☐ Active Surcharge Present

DEBRIS ON CHANNEL REMAINS FROM SURCHARGE

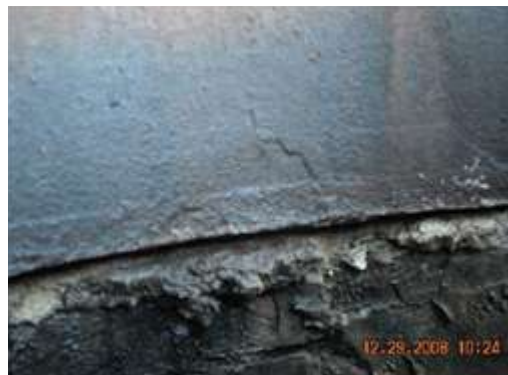
Defect 3

Condition: ☐ Sound ☒ **Cracked** ☐ Root Intrusion ☐ Loose Brick ☐ Deteriorated

1" GAP BETWEEN FRAME AND CHIMNEY, CRACKED CHIMNEY

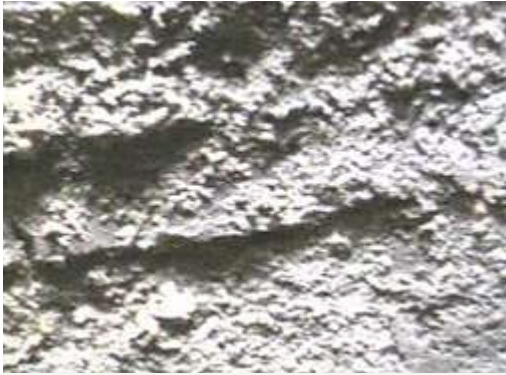
Defect 5

ACCUMULATION OF DEBRIS ON
CORBEL WALL ASSOCIATED WITH
INFLOW DUE TO SHEETING

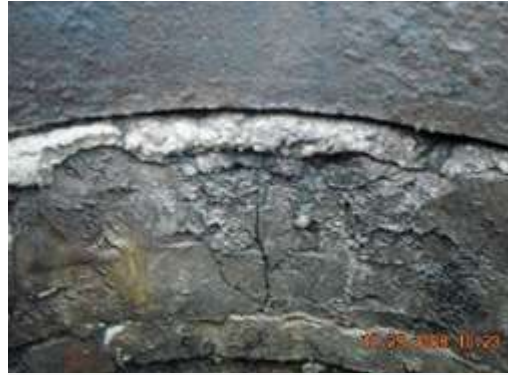
Defect 1

CHIMNEY ADJUSTMENT OF 8 INCHES
HAS CRACKS

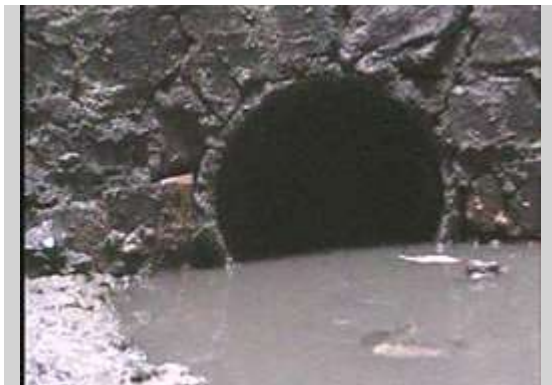
12 O'Clock Outflow

10 in. Circular Gravity Sewer
Pipe Out @ 12 O'Clock

Infiltration: **None** Pipe Seal Cond: **Sound**
